ELMCREST DAM

NDI ID NO. PA-00347
DER ID NO. 35-142

PHASE I INSPECTION REPORT,
NATIONAL DAM INSPECTION PROGRAM

JULY 1981

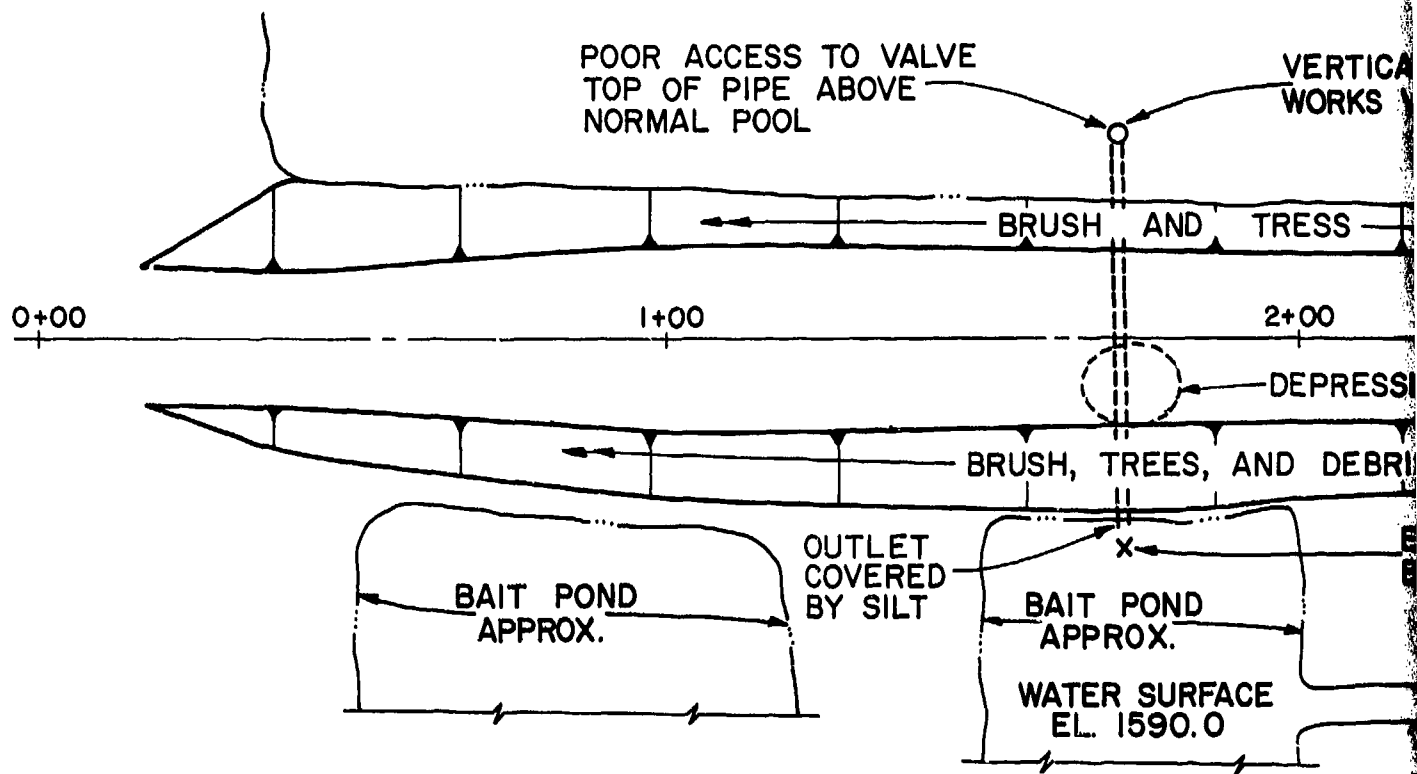
PLAN

a. General. The overall appearance of the dam and appurtenant structures is fair. Deficiencies were observed as noted below. A sketch of the dam with the locations of the deficiencies is presented on Exhibit B-1 in Appendix B. Survey information acquired for this Report is on Plate E-2 in Appendix E. Datum used for the survey was the spillway crest, Elevation 1595.1, as estimated from USGS contour mapping. On the day of the inspection, the pool elevation was 0.5 foot above the spillway crest level.

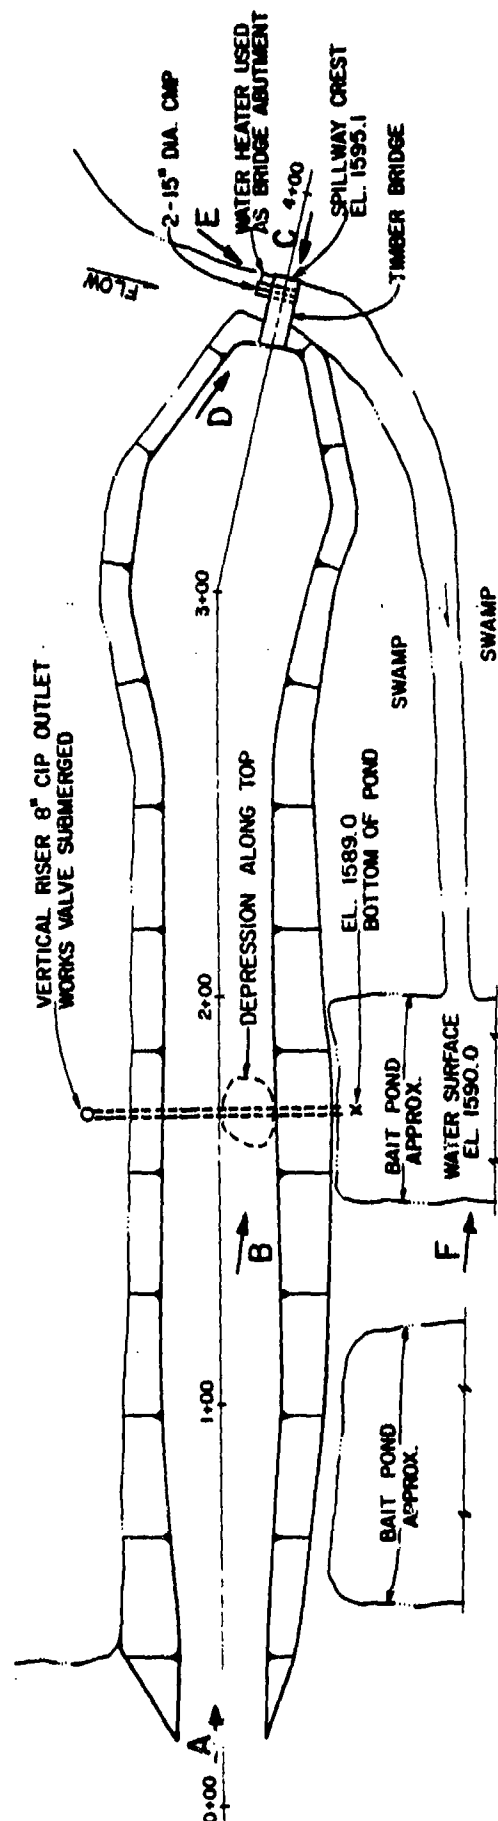
Two bait ponds extend downstream from the embankment, as shown on Plate E-2. Both the outlet works and the spillway channel discharge into the leftmost bait pond (Photograph F). The area between this bait pond and the spillway is a swamp. The swamp, which is heavily overgrown, extends for a significant distance downstream from the embankment. No seepage areas were observed, although they could have been obscured by the pond, swamp, and flow from the spillway.

F. Confluence of Spillway Exit Channel and Bait Pond

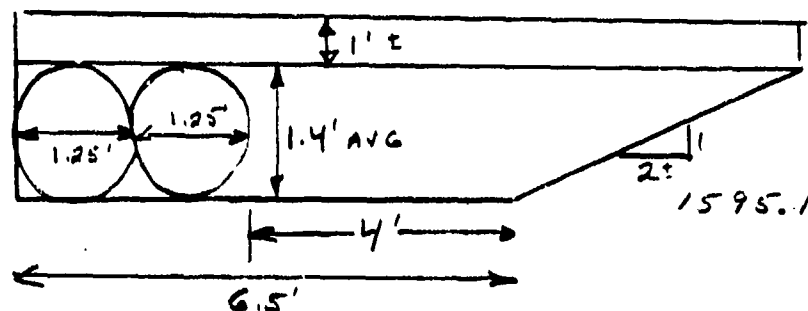
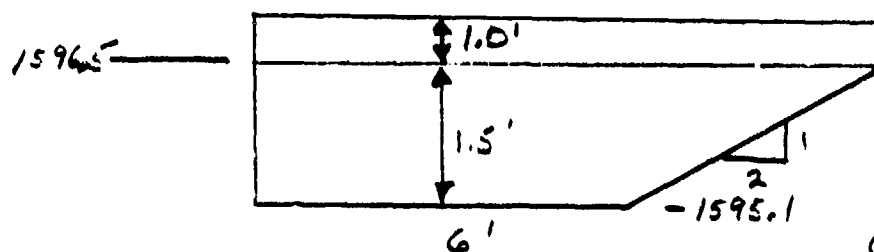
(3) Appurtenant Structures. For low-flow conditions, the approach losses in the spillway approach channel are judged to be appreciable; this explains the 0.5 foot difference in head between the spillway crest elevation and the pool elevation on the day of the inspection, when the quantity of flow was relatively small. As the pool elevation increases, the approach losses should become insignificant. The fish screen in the approach channel is judged to have no significant effect because it would collapse during any significant flow. However, the spillway itself is judged to have a very large potential to collect debris during a flood. It is conceivable that sufficient debris could collect to completely block the spillway. There is an erosion potential at the right end of the spillway, which is the left end of the embankment.

Approach losses ARE JUDGED APPROPRIATE FOR LOW FLOWS AND LESS FOR POOL NEAR TOP OF DAM.

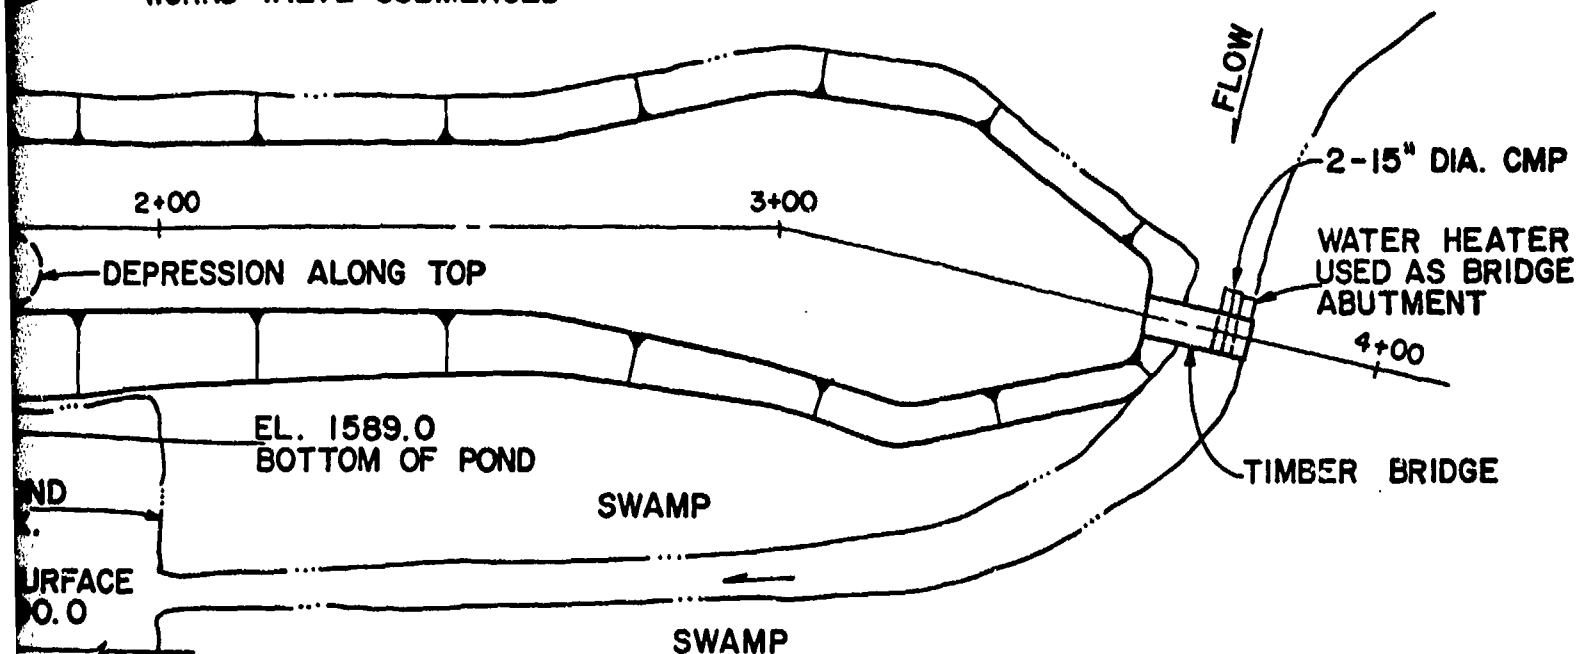
PLAN
SCALE: 1 IN. = 30 FT.

A minor amount of debris is accumulated at the spillway (Photograph E). The CMPs in the spillway are corroded through. The area of natural ground to the left of the spillway is heavily overgrown with thick brush and small trees. The right side of the spillway is the embankment. It is covered with vegetation. The spillway exit channel is not well-defined as it extends through the swamp to the bait pond.

(3) Appurtenant Structures. Although the pipes at the spillway are deteriorated, they do not affect the structural integrity of the dam. No structural deficiencies were observed at the outlet works.
